## Acoustic Microscopy, a Tool for Evaluating Quality of Microelectronics

**Stephen Bolin**

Jet Propulsion Lab, Pasadena, California

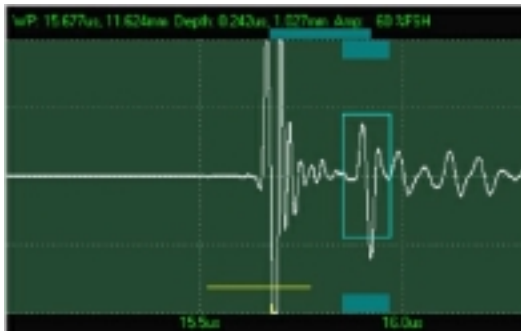
Figure 1 - A Scan

The SAM functions by sending pulses of extremely high frequency sound waves (10-210 megahertz) into a sample that is submerged in a fluid. Where discontinuities exist in the sample, the sound is reflected back to the transducer which functions both as the sound source and the detector. Reflections at a point are referred to as an A-scan. They are displayed as an oscilloscope trace as shown in Figure 1.
